TRAINING COURSE **MAINTENANCE** PROGRAMS

CHwB Kosovo office
Report series No. 4/2006

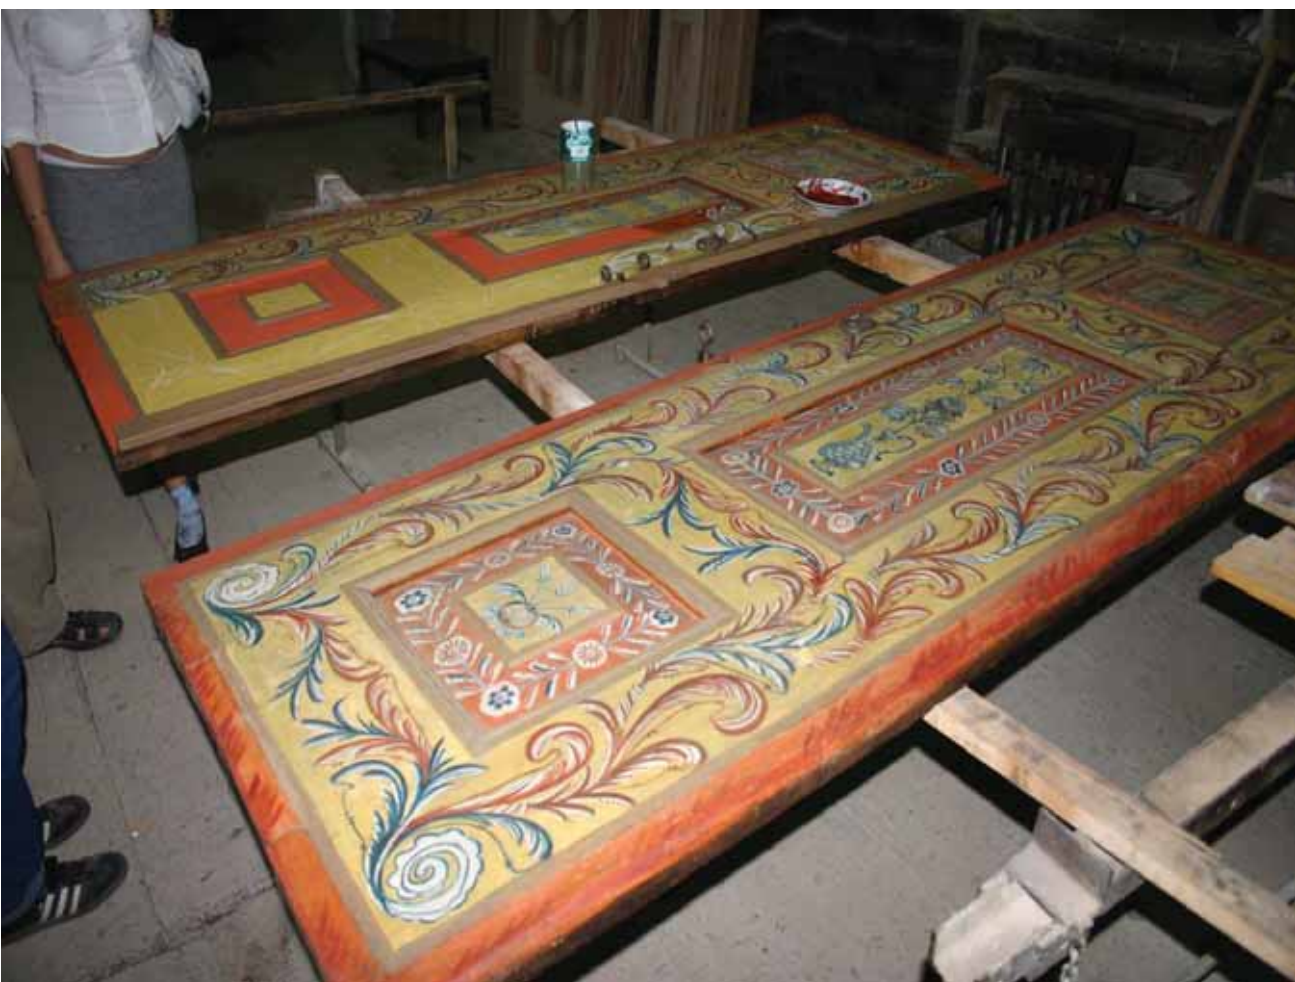
The entrance door in the Hadum
Mosque in Gjakova, before, during and
after the restoration.
Done by Tody Cezar, during the
Summer 2005.
